GRIGG & DAVIS ENGINEERS, P.C.

Re: Pre-Construction Surveys for existing Buildings and Retaining Wall, Periodic Monitoring of Retaining Wall Stability during construction, and Post-Construction Surveys for existing Buildings along Cannon Place – Bronx, NY

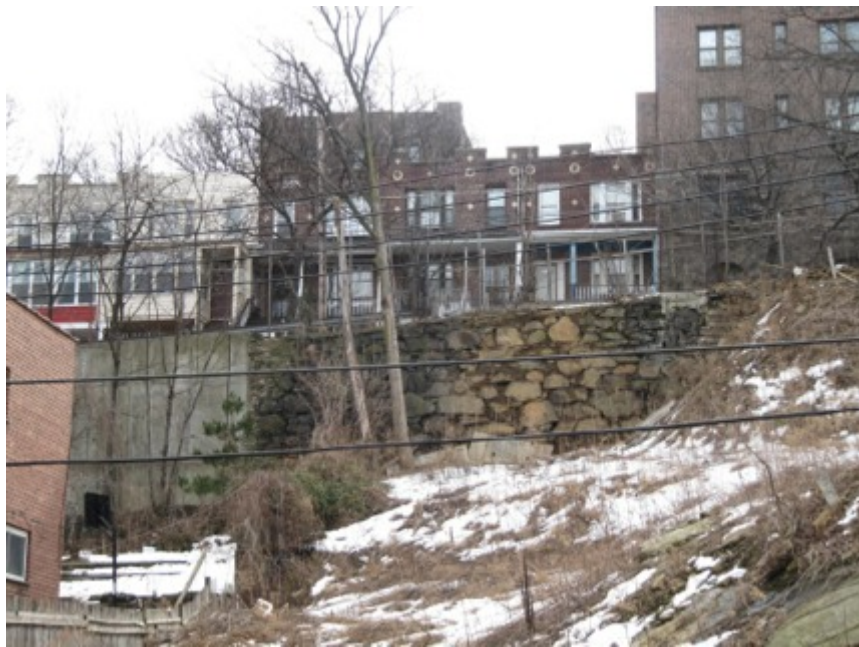
2. The concrete sidewalk at the south end of the retaining wall is in very poor condition due to settlement. See Photograph 6. This settlement is being caused by the loss of the fine soil particles through the retaining wall due to ground water movement. In Photograph 2 the light brown color on the face of the retaining wall is the fine soil particles being washed out.
