# **GRIGG & DAVIS ENGINEERS, P.C.**

March 12, 2010

Re: Pre-Construction Surveys for existing Buildings and Retaining Wall, Periodic Monitoring of Retaining Wall Stability during construction, and Post-Construction Surveys for existing Buildings along Cannon Place – Bronx, NY

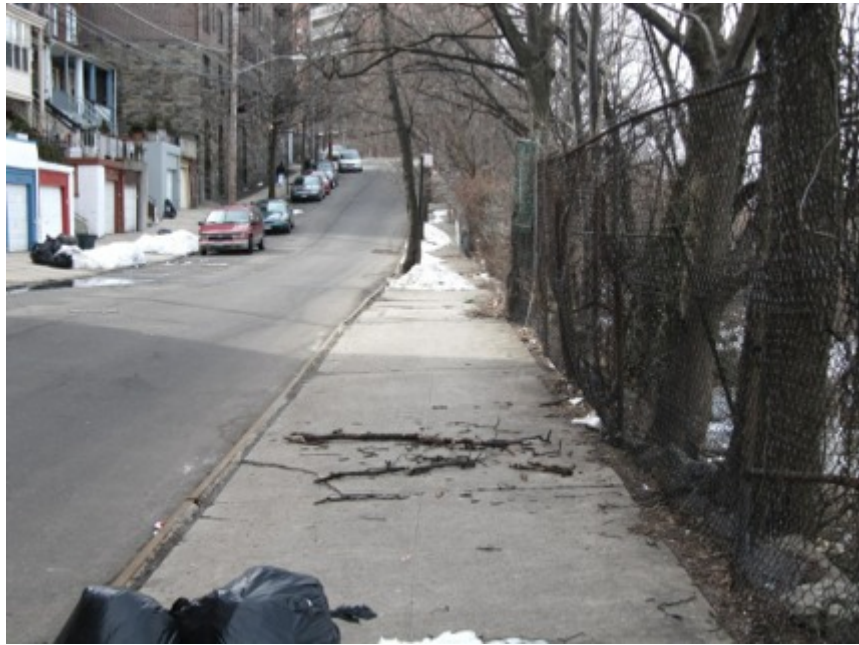
Photograph 1

The concrete sidewalk at the north end of the retaining wall has negligible settlement. See Photograph 1.

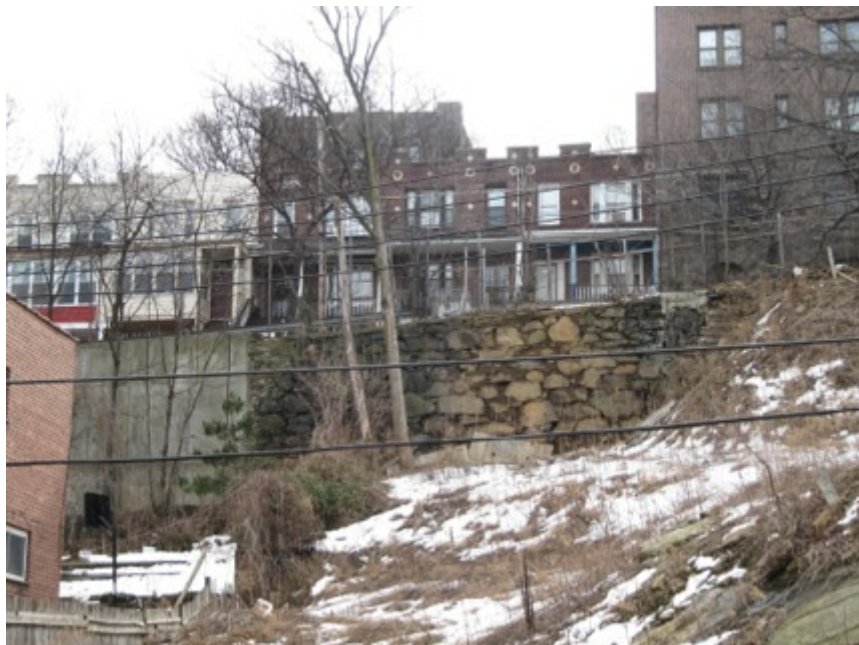
2. The concrete sidewalk at the south end of the retaining wall is in very poor condition due to settlement. See Photograph 6. This settlement is being caused by the loss of the fine soil particles through the retaining wall due to ground water movement. In Photograph 2 the light brown color on the face of the retaining wall is the fine soil particles being washed out.

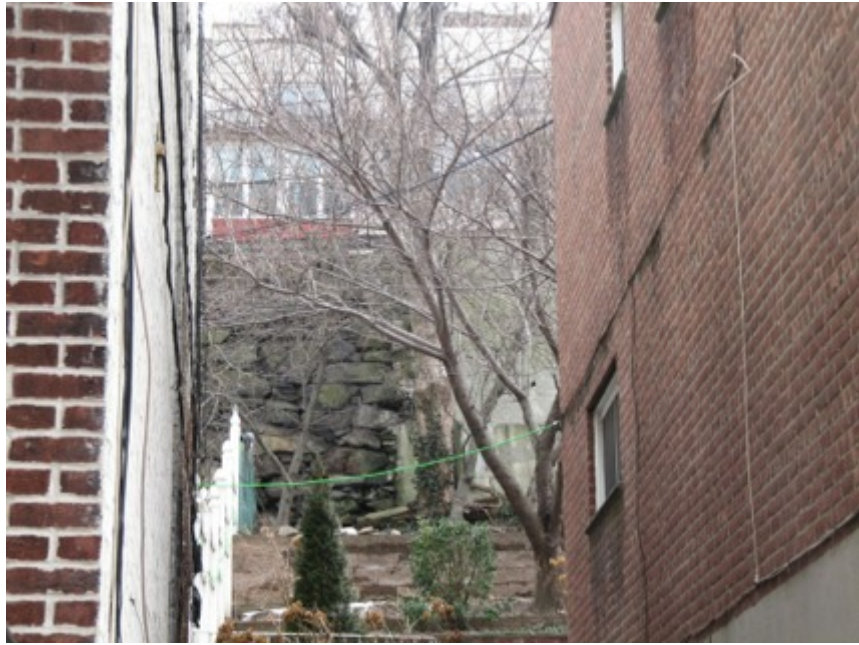
Photograph 3

1. The retaining wall is on the west side of Cannon Place and is constructed of rubble stone without mortar (dry-laid). The height of the retaining wall varies and has a maximum height of approximately 20'-0". The top of the retaining wall is approximately 7'-0" away from the west curb of Cannon Place. See Photograph 1. The face of the retaining wall has several areas where the rubble stone has shifted outward and is bowing. An approximately 20'-0" long section of the retaining wall has been replaced with a poured concrete retaining wall. See Photographs 2 and 3. The construction joints at each end of the poured concrete section of retaining wall indicate that the retaining wall has continued to move since the poured concrete section was installed. Photograph 4 is the southern construction joint and Photograph 5 is the northern construction joint.

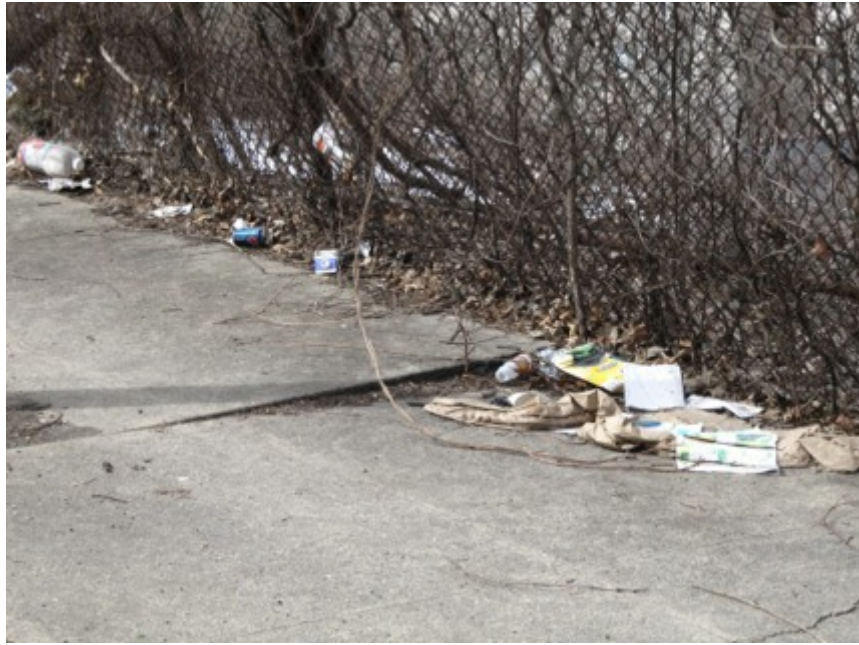
Photograph 7

The concrete sidewalk at the middle of the retaining wall has also settled and is uneven. See Photograph 7. This movement is the result of the retaining wall shifting which allows the soil behind the retaining wall to settle as the volume of soil redistributes itself.

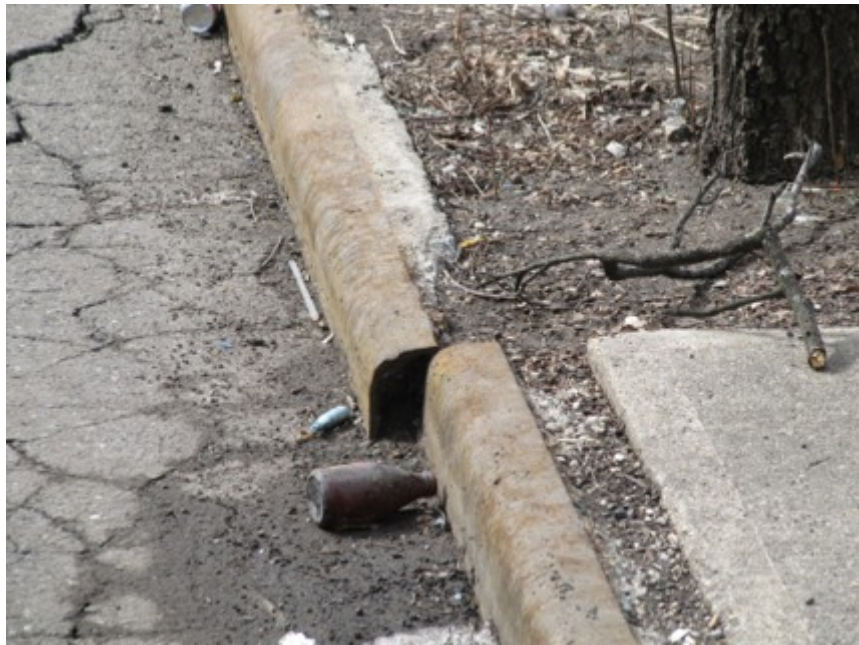
Photograph 8

3. One section of concrete curb along the west side of Cannon Place at the middle of the retaining wall has shifted west approximately 2". See Photograph 8. This movement is the result of the retaining wall shifting and the volume of soil behind the retaining wall redistributing itself.
4. A section of the asphalt pavement adjacent to the shifted concrete curb is breaking up. See Photograph 9. This breaking up is the result of the retaining wall shifting and the volume of soil behind the retaining wall redistributing itself.
5. The Site of the proposed new Building is the side of a hill with a rock outcrop along Fort Independence Street.
